P.I.N. X051.59  
BRIDGE DECK EVALUATION REPORT

<u>Description:</u>	Grand Central Parkway over Winchester Blvd and Cross Island Parkway and Ramp "H" over Cross Island Parkway
<u>BIN:</u>	1065149 and 106514A
<u>GCP Reference Marker:</u>	1120 to 1124
<u>County:</u>	Queens
<u>City of:</u>	New York
<u>Region:</u>	11
<u>Feature Carried:</u>	Grand Central Parkway and GCP Ramp "H"
<u>Feature Crossed:</u>	Cross Island Parkway Winchester Blvd

# IN-DEPTH INSPECTION REPORT

**B.I.N. 1-06514-9 & 1-06514-A**

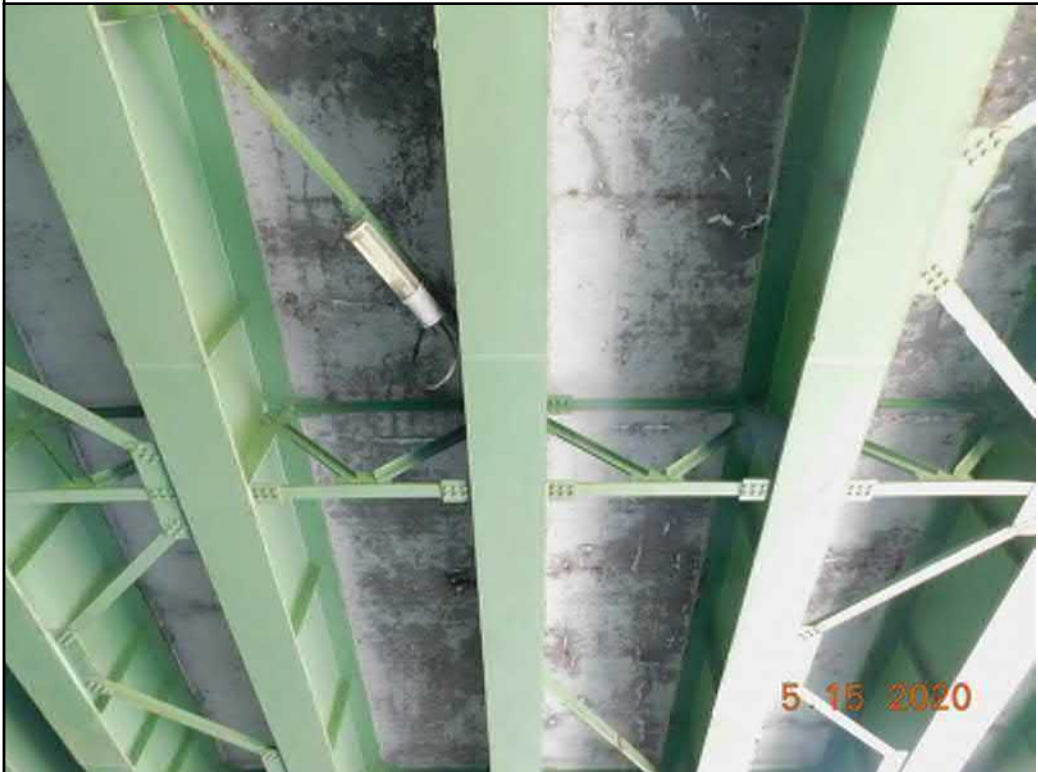
Photo Number: 10 Photo Filename: 20\_SW\_6106.JPG

- Spalls up to 3" deep with exposed epoxy painted or corroded rebar. (Photos 7-9,11,12, & 14)
- Transverse cracks up to 1/4" wide with/without efflorescence.(Photo 10 & 14)
- Fine mapcracking with/without efflorescence. (Photo 10,11, & 13)
- Areas of dampness on the underside of the deck due to seepage through the concrete deck. (Photo 10,11,13, & 14)

Location: Span 5, Bays 12-13 at Diaph. D3-5; Looking Up and Ahead. Dampness, fine mapcracking with/without efflorescence.

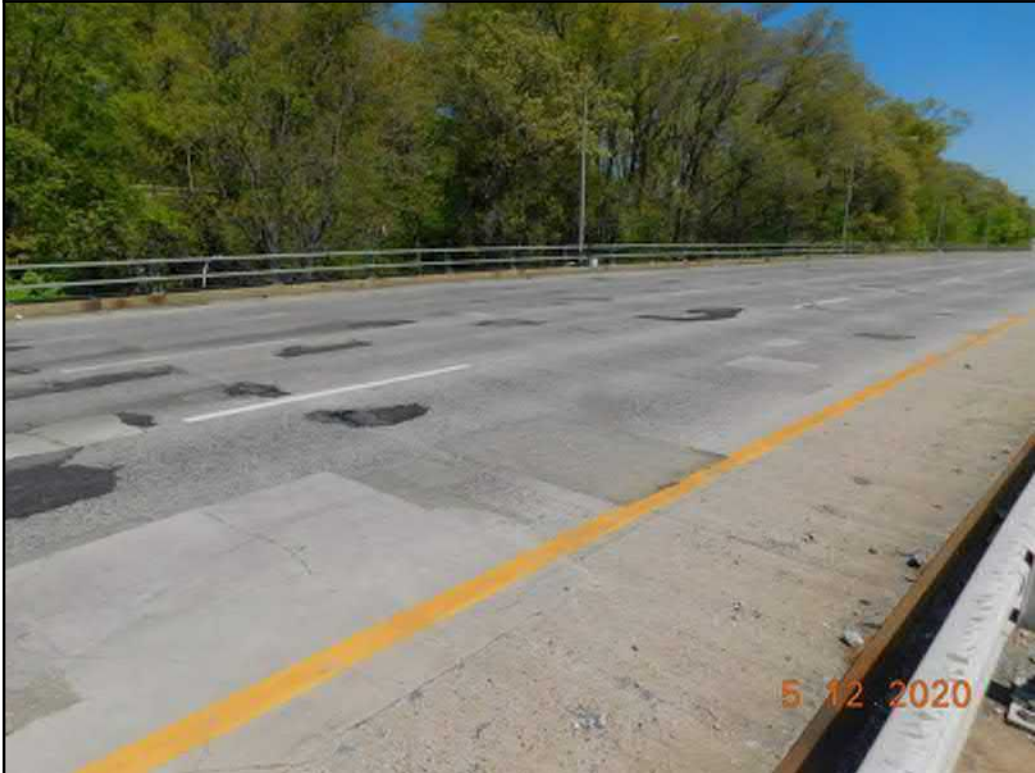
Photo Number: **15** Photo Filename: **20\_SW\_6060.JPG**

The concrete wearing surface exhibits several shallow spalls up to 2 SF in the WB roadway. Additionally, there are scattered uneven asphalt patches throughout.

**Attachment Description:**  
Location: Spans 1-2, W/B  
Wearing Surface; Looking  
Ahead and Left. Shallow  
spalls and uneven asphalt  
patches.

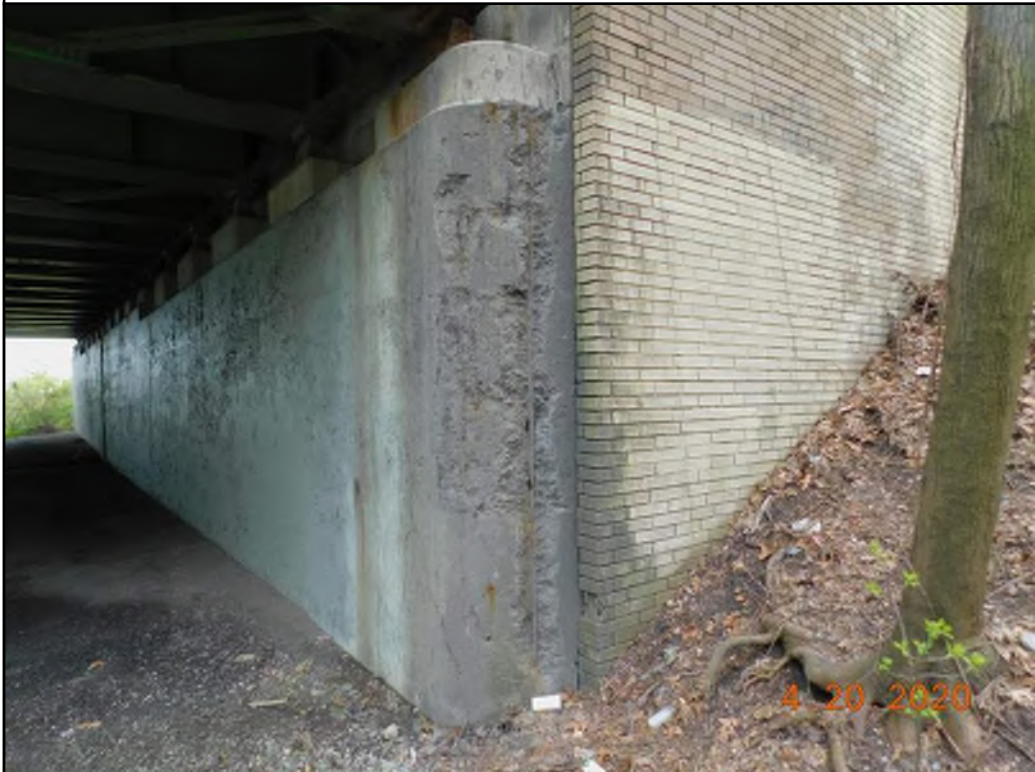
Photo Number: **16** Photo Filename: **20\_SW\_5580.JPG**

Span 1: BA215 - Reinforced Concrete Abutment	TQ	CS-1	CS-2	CS-3	CS-4	CS-5
	128	50	75	3	0	0
<b>Condition State 3 Note</b> <b>Referenced Photo(s):</b> 16 <b>Referenced Sketch(es):</b> None						
Begin Abutment reinforced concrete stemwall adjacent to left wingwall exhibits spall up to 3' wide x full height x 2.5" deep with exposed and partially debonded corroded vertical rebar. In addition, there are scattered vertical cracks up 3/16" wide along the bottom of the wall.						
Span 1: BA311 - Movable Bearing	TQ	CS-1	CS-2	CS-3	CS-4	CS-5
	17	16	0	1	0	0
<b>Condition State 3 Note</b> <b>Referenced Photo(s):</b> 17 <b>Referenced Sketch(es):</b> None						
Girder G1 Bearing exhibits pack rust up to 1/2" between the rocker and masonry plate and minor pitting section loss.						
Span 1: BA311 - Movable Bearing-515 - Steel Protective Coating	TQ	CS-1	CS-2	CS-3	CS-4	CS-5
	34	32	0	0	2	0
<b>Condition State 4 Note</b> <b>Referenced Photo(s):</b> 17 <b>Referenced Sketch(es):</b> None

**Attachment Description:**  
Location: Begin Abutment,  
Left Side; Looking Back and  
Right. Spall with exposed  
debonded rebar.

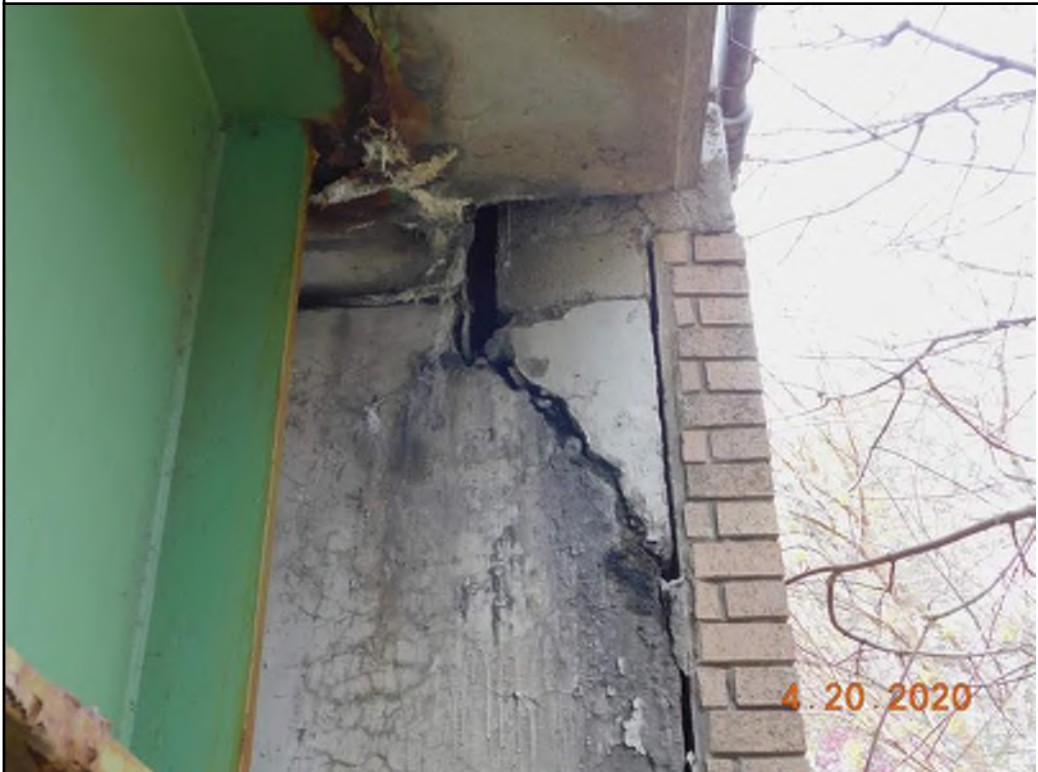
Photo Number: 18 Photo Filename: 20\_SW\_5582.JPG

At the Begin Abutment, the paint at the Girder G1 Bearing has failed allowing corrosion of the bearing steel.						
Span 1: BA850 - Backwall	TQ	CS-1	CS-2	CS-3	CS-4	CS-5
	128	0	126	2	0	0
<b>Condition State 3 Note</b> <b>Referenced Photo(s):</b> 18 <b>Referenced Sketch(es):</b> None						
The backwall exhibits a 2' (L) x up to 1" (W) diagonal crack at the top left corner of the backwall to the left of Girder G1. The area of backwall above the diagonal crack is hollow sounding but stable.						
Span 1: PR852 - Pier Pedestal	TQ	CS-1	CS-2	CS-3	CS-4	CS-5
	17	0	16	1	0	0
<b>Condition State 3 Note</b> <b>Referenced Photo(s):</b> 19 <b>Referenced Sketch(es):</b> None						
Pier 1, pedestal #10 at left face exhibits a spall up to 27" L x 16" H x 4" deep with exposed corroded and debonded horizontal rebar with cracks up to 1/4" (W). The bearing is not undermined.						
Span 2: 330 - Metal Bridge Railing Span 3: 330 - Metal Bridge Railing Span 4: 330 - Metal Bridge Railing Span 15: 330 - Metal Bridge Railing	TQ	CS-1	CS-2	CS-3	CS-4	CS-5

**Attachment Description:**  
Location: Begin Abutment,  
Backwall, Left Side; Looking  
Back. Diagonal crack at top  
of backwall.

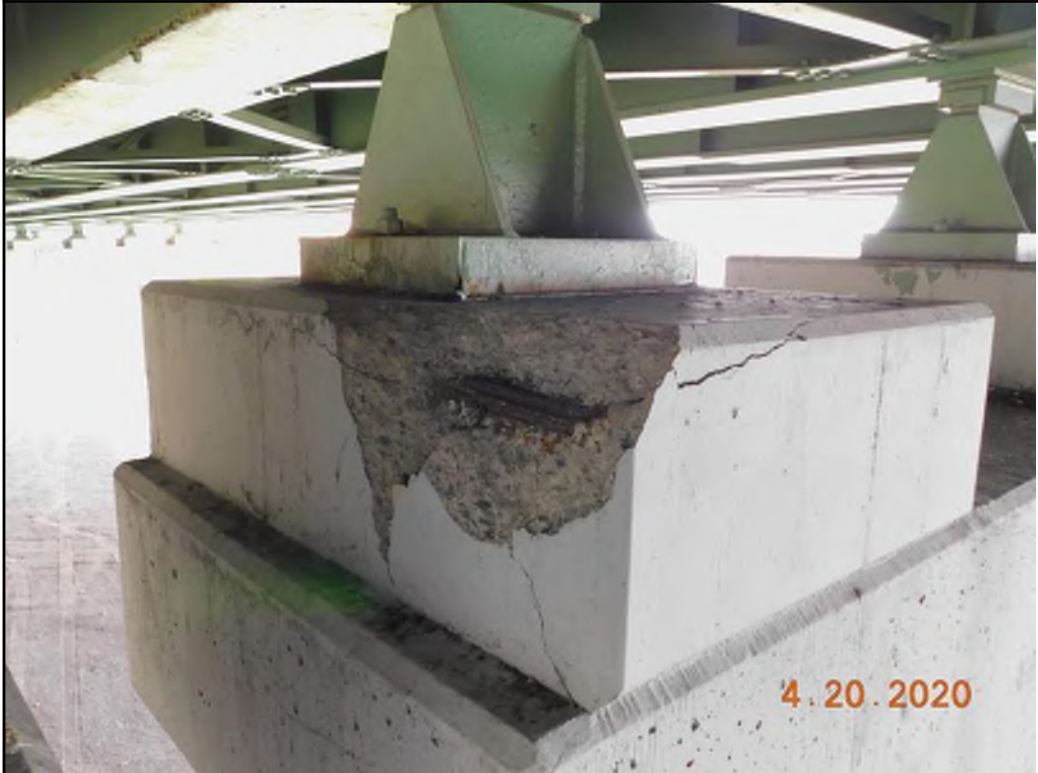
Photo Number: 19

**Attachment Description:**  
Location: Pier 1, Pedestal  
#10; Looking Ahead and  
Right. Spall with exposed  
rebar and cracks. (Typical)

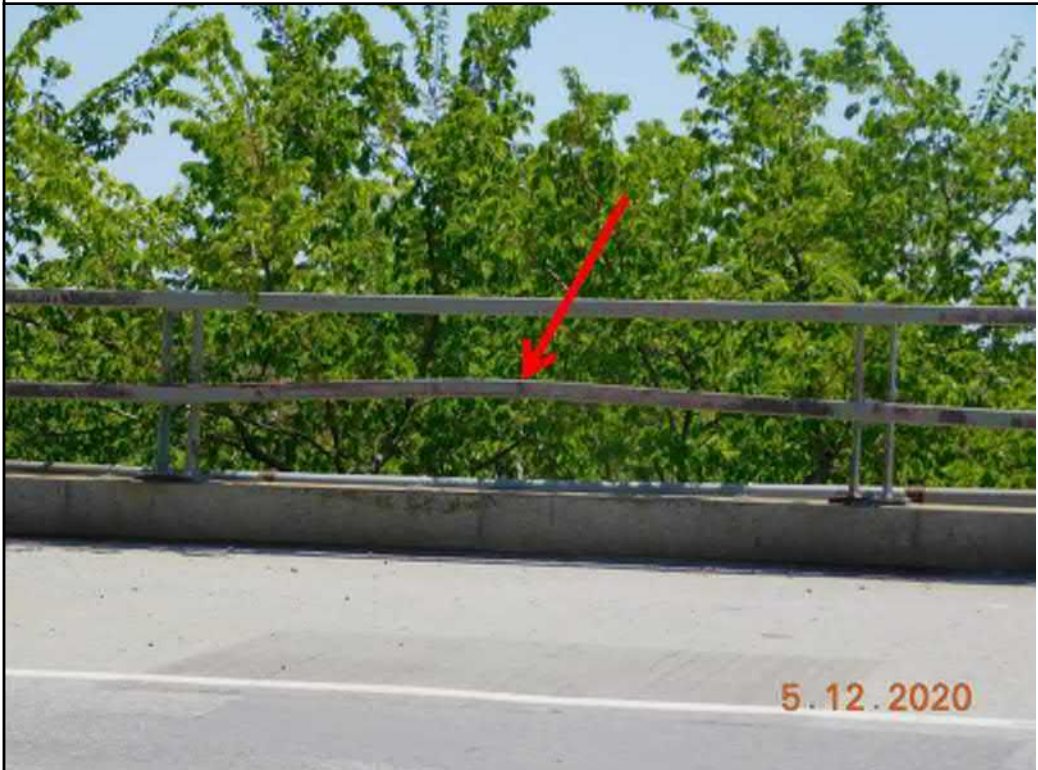
Photo Number: 20

447	317	112	18	0	0
	315	222	79	14	0	0
	336	240	84	12	0	0
	360	255	90	15	0	0
<b>Condition State 3 Note</b> <b>Referenced Photo(s):</b> 5, 6, 20 <b>Referenced Sketch(es):</b> None						
The median railing at the following locations has been impacted which has bent or broken the posts:						
-Span 2, E/B Median Railing: 10' (L) segment of impacted railing with one bent post. (Typical Photo 5) -Span 3, W/B Median Railing: 14' (L) segment of impacted railing with one bent post. (Photo 5) -Span 4, E/B Median Railing: 12' (L) segment of impacted railing with one bent post with a crack at its base. (Photo 6) -Span 15, E/B Median Railing: 15' (L) segment of impacted railing with one bent post with a crack at its base. (Typical Photo 6)

**Attachment Description:**  
Location: Span 2, Right  
Metal Railing; Looking  
Right. Bent lower rail.  
(Typical)

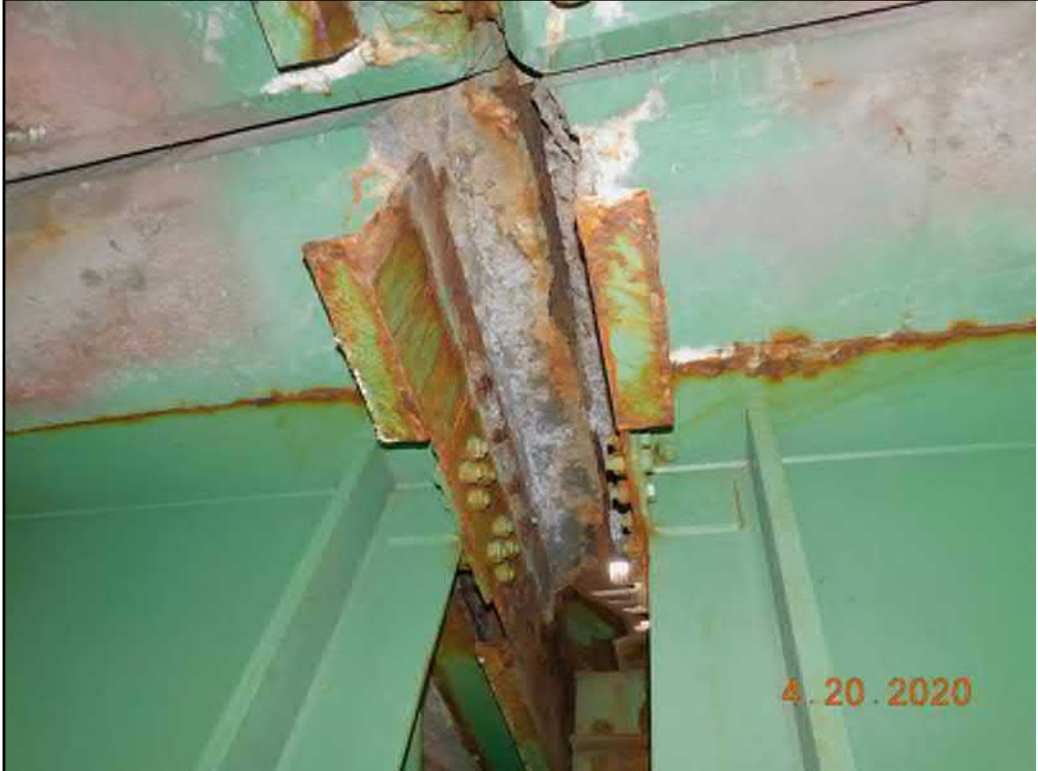
Photo Number: 21 Photo Filename: 20\_SW\_5601.JPG

**Attachment Description:**  
Location: Span 3, Bays 9-10  
at Pier 3 Joint; Looking  
Right. Spalled underside of  
deck at joint.

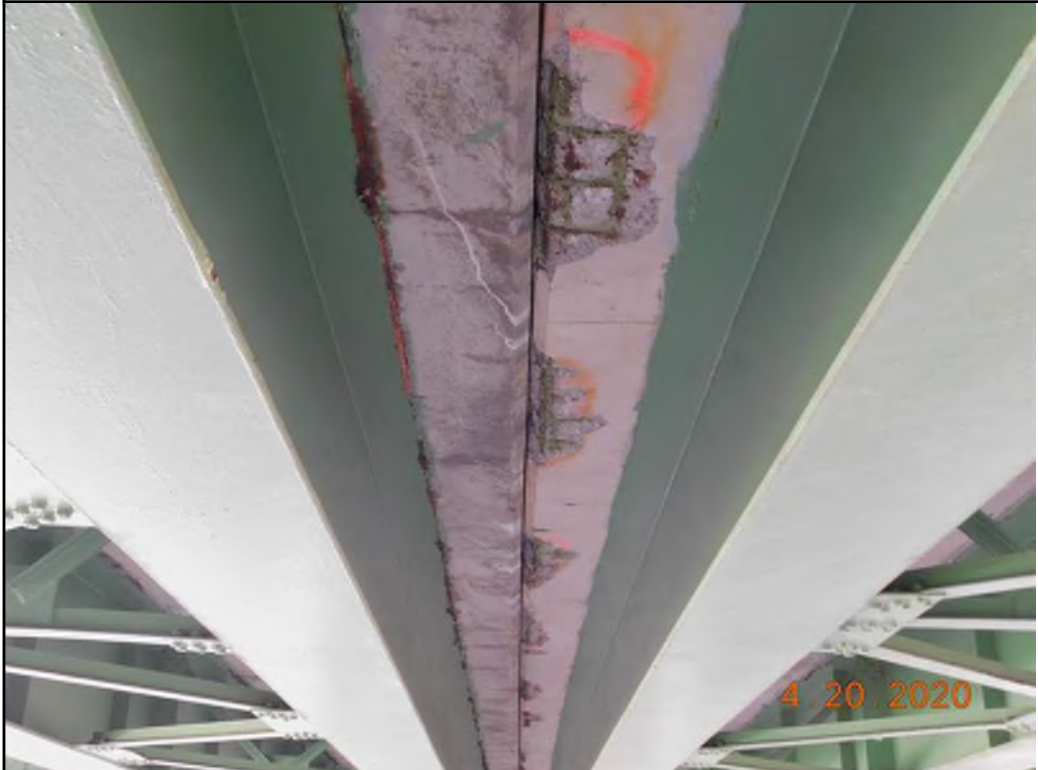
Photo Number: 22 Photo Filename: 20\_SW\_5606.JPG

**Attachment Description:**  
Location: Span 3, Bay 9;  
Looking Back. Spalls with  
exposed concrete.

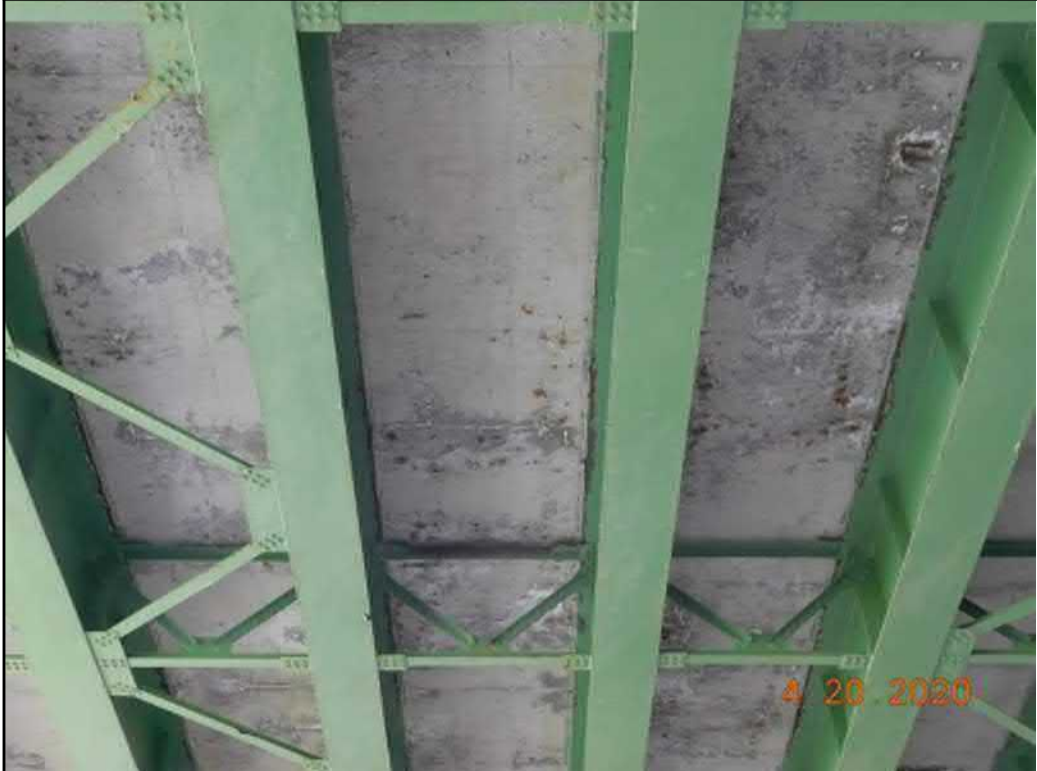
Photo Number: 23 Photo Filename: 20\_SW\_5610.JPG

**Attachment Description:**  
Location: Span 3, Bays 12-14 at Diaph. D2-3; Looking Up and Back. Dampness, mapcracking, and spalls with efflorescence.

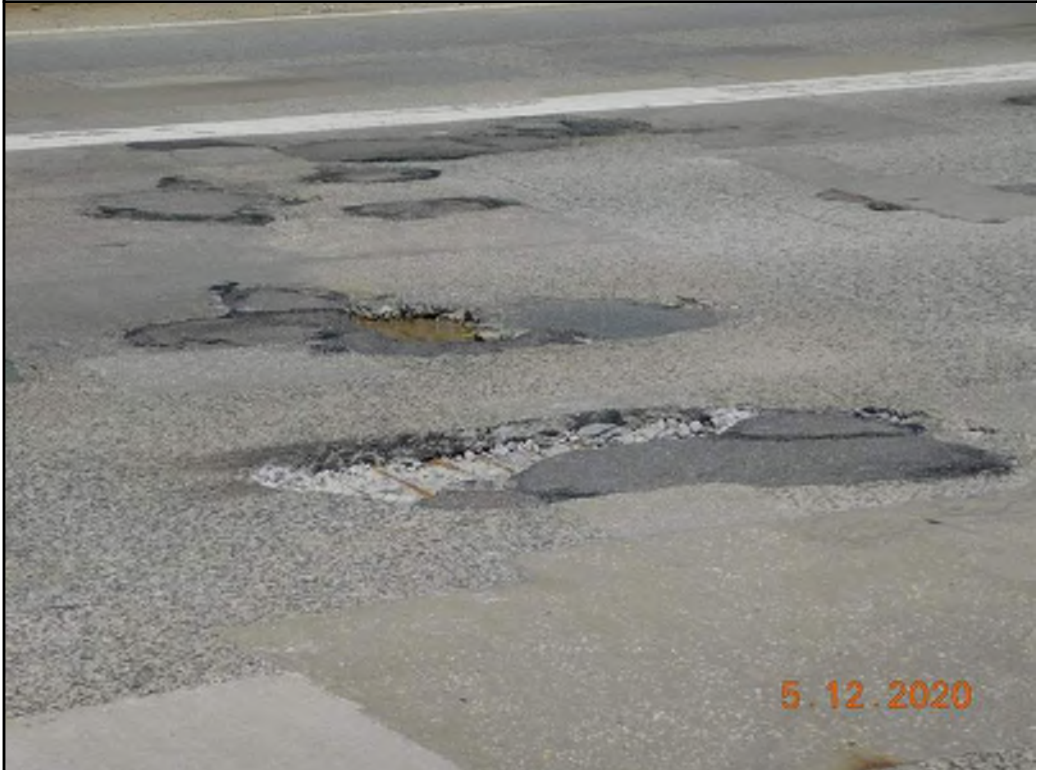
Photo Number: 24 Photo Filename: 20\_SW\_6065.JPG

**Attachment Description:**  
Location: Span 3, W/B Wearing Surface; Looking Left. Spalls and uneven asphalt patches.

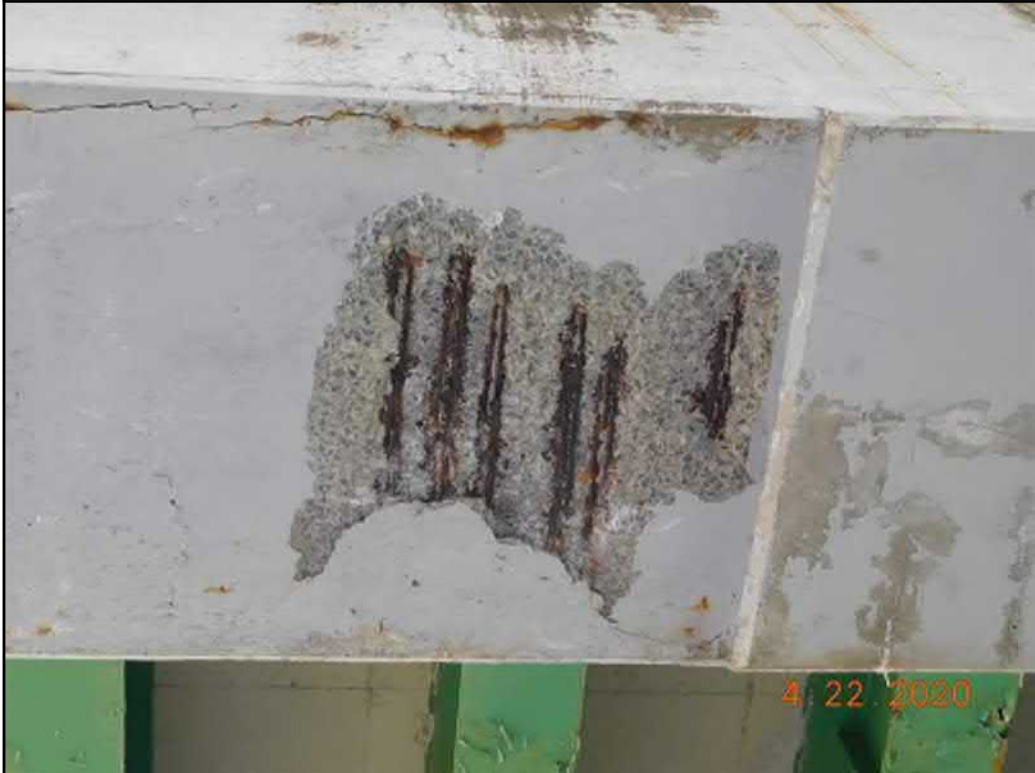
Photo Number: 25 Photo Filename: 20\_SW\_5649.JPG

Location: Pier 3, Pier Cap,  
Underside under Bay 3;  
Looking Up and Ahead.  
Spall with exposed rebar.

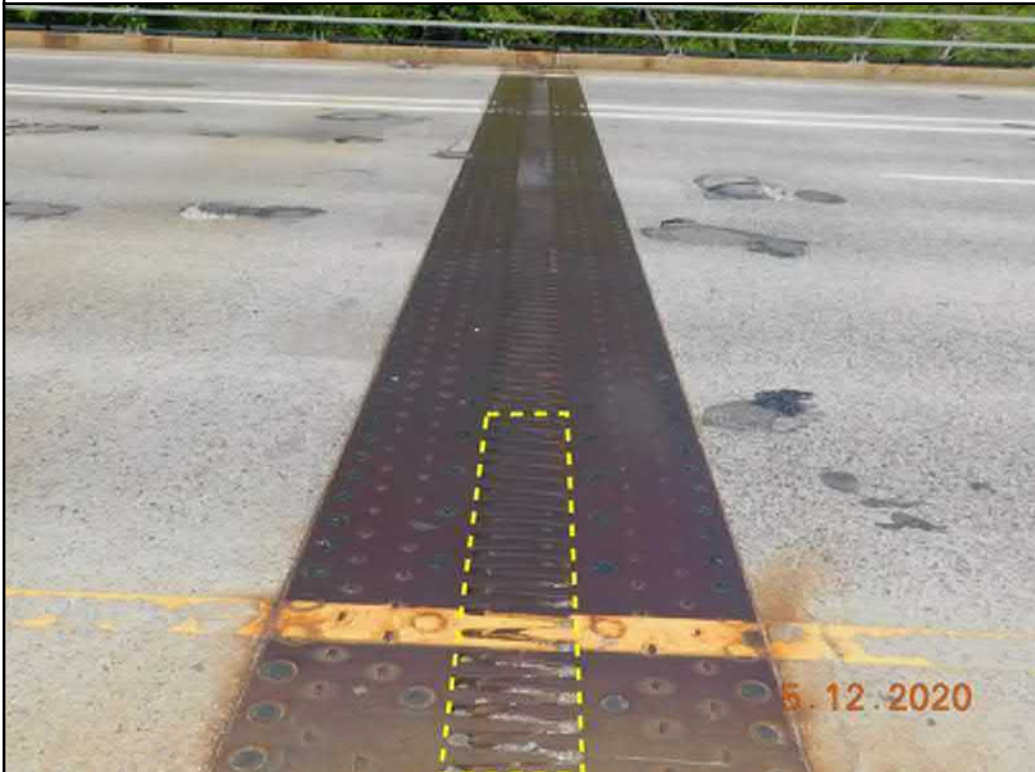
Photo Number: 26 Photo Filename: 20\_SW\_6069.JPG

Location: Pier 3, W/B Joint;  
Looking Left. Joint filled with  
dirt and debris.

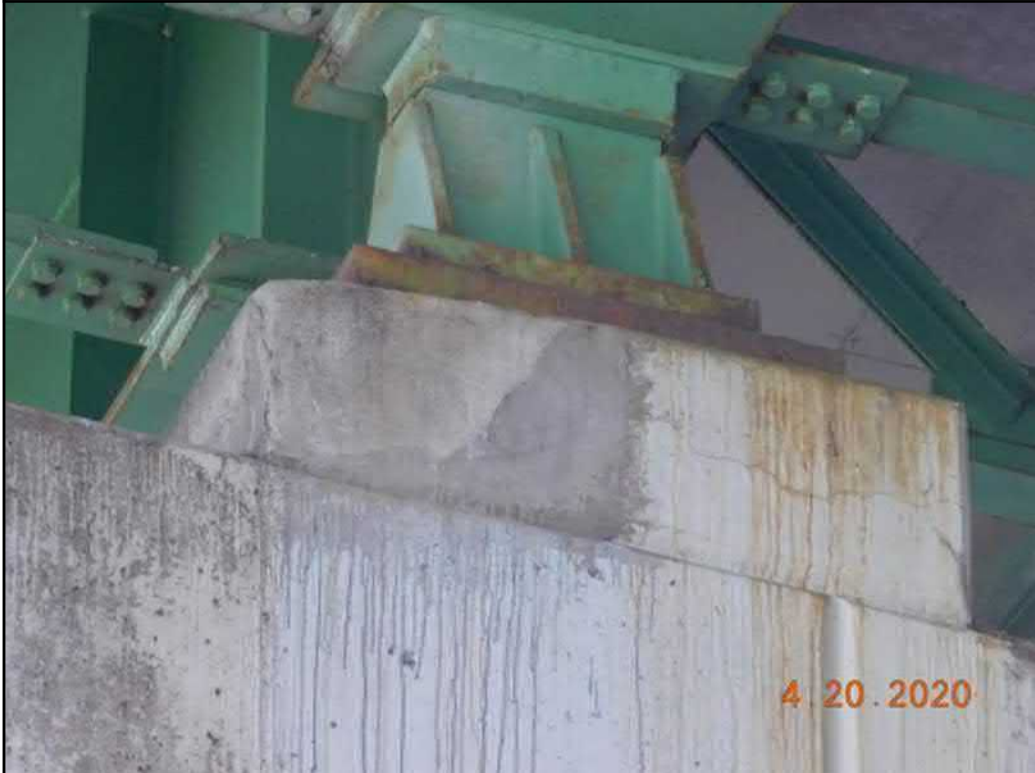
Photo Number: 27 Photo Filename: 20\_SW\_5609.JPG

**Attachment Description:**  
Location: Pier 3, Pedestal  
#15, end face; Looking  
Back. Repaired pedestal  
spall. Ref. Improvements  
Observed.

2020: At Pier 3, the end face of Pedestal #15 which was spall has been repaired. (Photo 27)

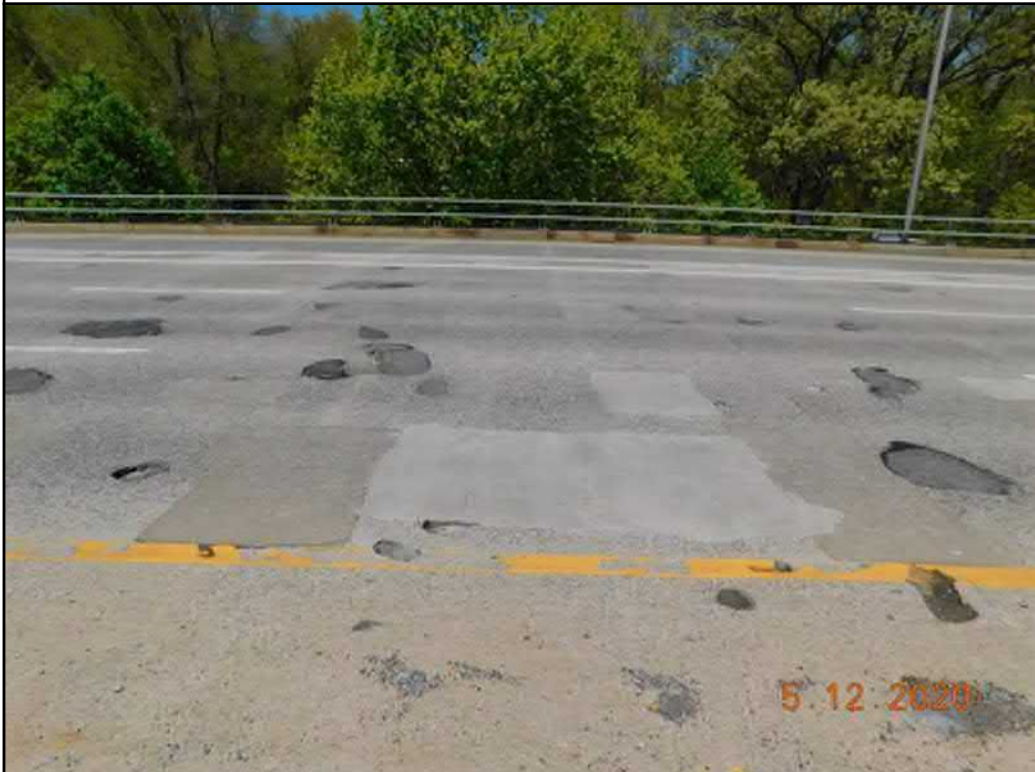
Photo Number: 28 Photo Filename: 20\_SW\_6074.JPG

**Attachment Description:**  
Location: Span 5, W/B  
Wearing Surface; Looking  
Left. Potholes and uneven  
asphalt patches.

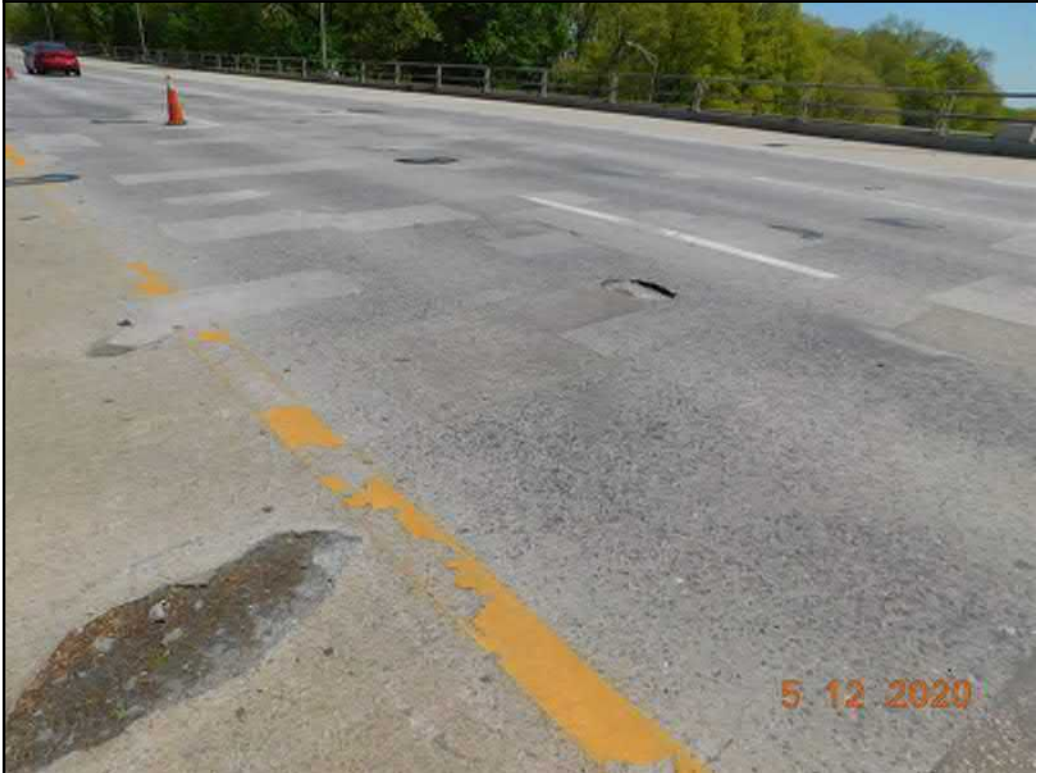
Photo Number: 29 Photo Filename: 20\_SW\_6083.JPG

**Attachment Description:**  
Location: Span 11, E/B  
Wearing Surface; Looking  
Ahead and Right. Potholes  
and uneven asphalt  
patches.

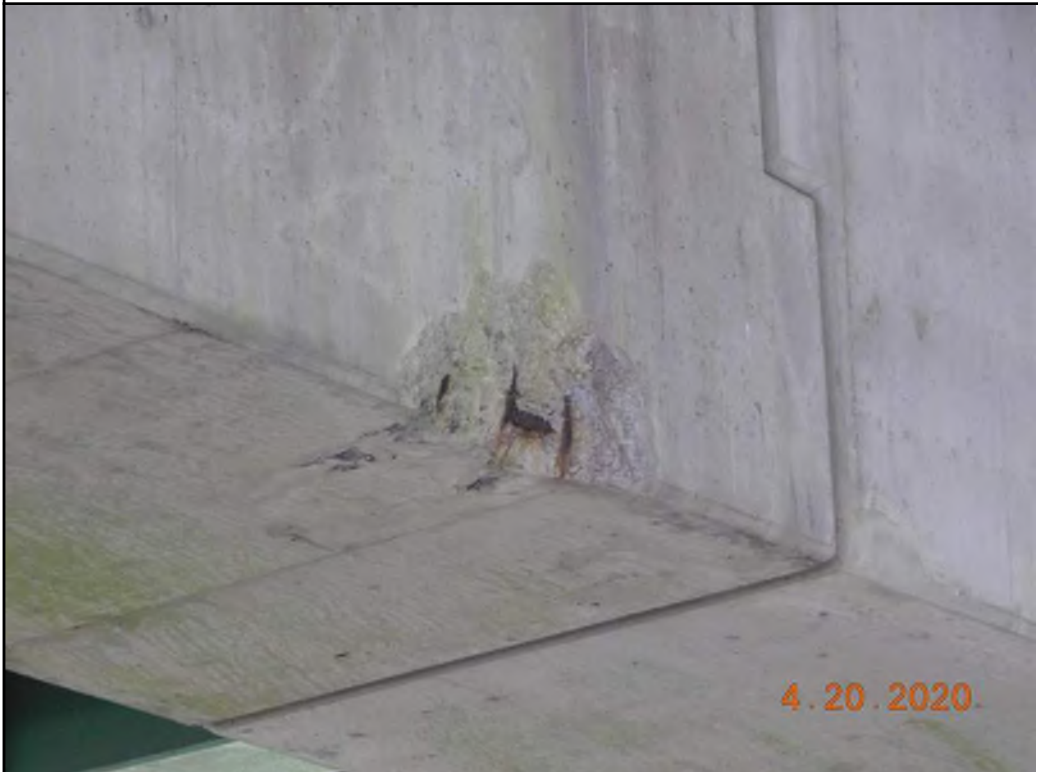
Photo Number: 30 Photo Filename: 20\_SW\_5611.JPG

**Attachment Description:**  
Location: Pier 4, Pier Cap,  
End Face under Bay 6;  
Looking Back and Left.  
Spall with exposed rebar.

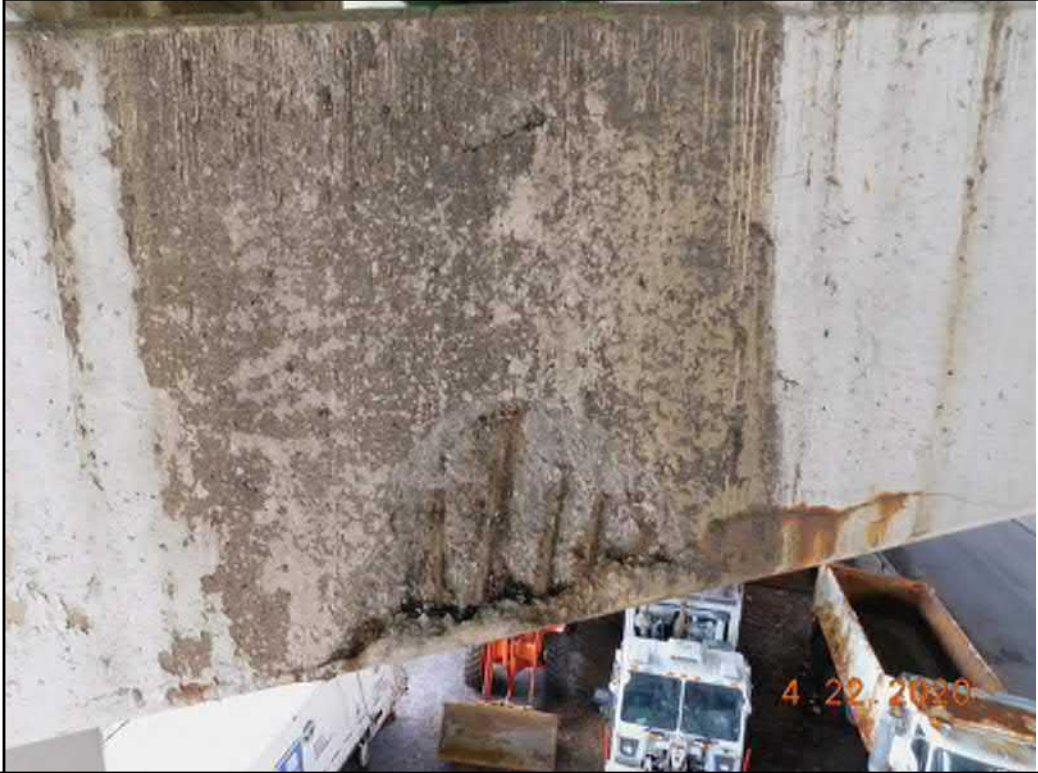
Photo Number: 31 Photo Filename: 20\_SW\_5624.JPG

**Attachment Description:**  
Location: Pier 6, Pier Cap,  
End Face under Bay 12;  
Looking Back. Spall with  
exposed rebar.

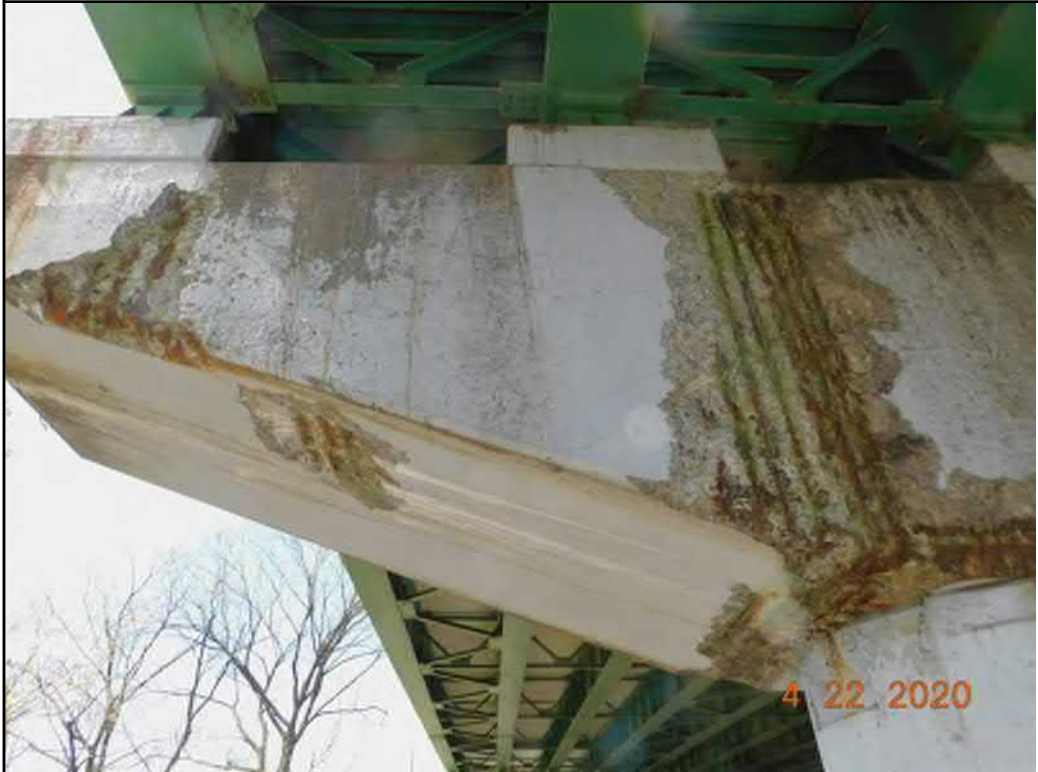
Photo Number: 32 Photo Filename: 20\_SW\_5634.JPG

**Attachment Description:**  
Location: Pier 6, Pier Cap,  
End face under Bays 17-18;  
Looking Back. Spalls with  
exposed rebar.

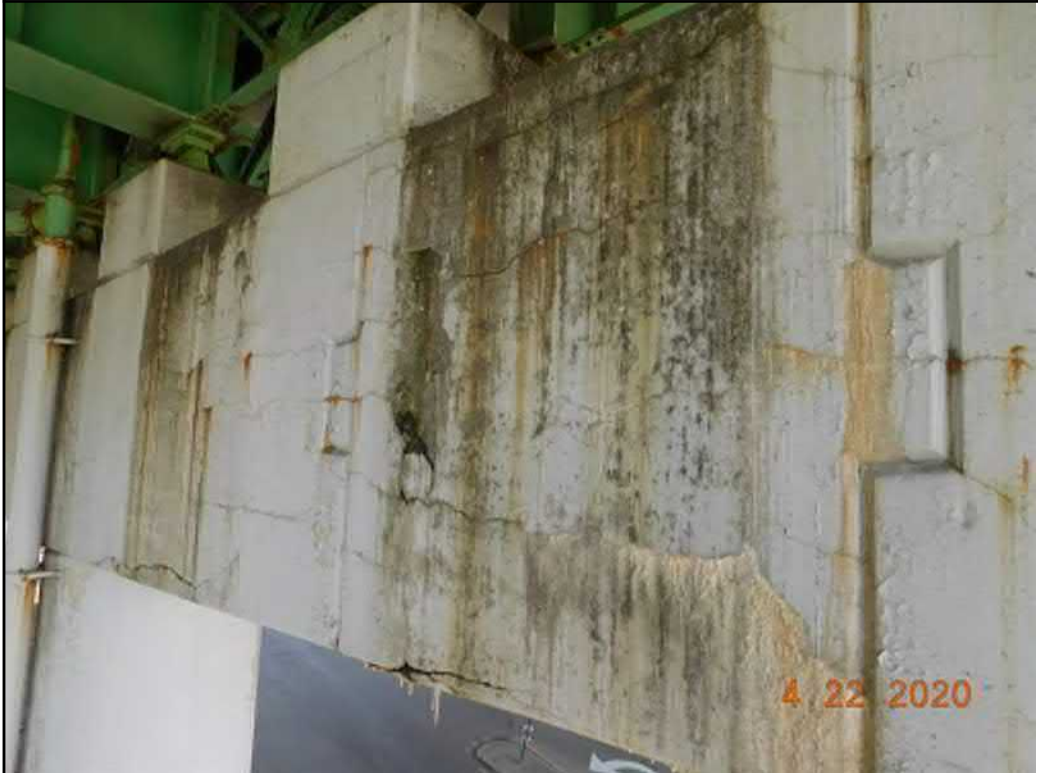
Photo Number: 33

Location: Pier 6, Begin Face under Bay 15; Looking Ahead and Left. Horizontal cracks with rust bleed.

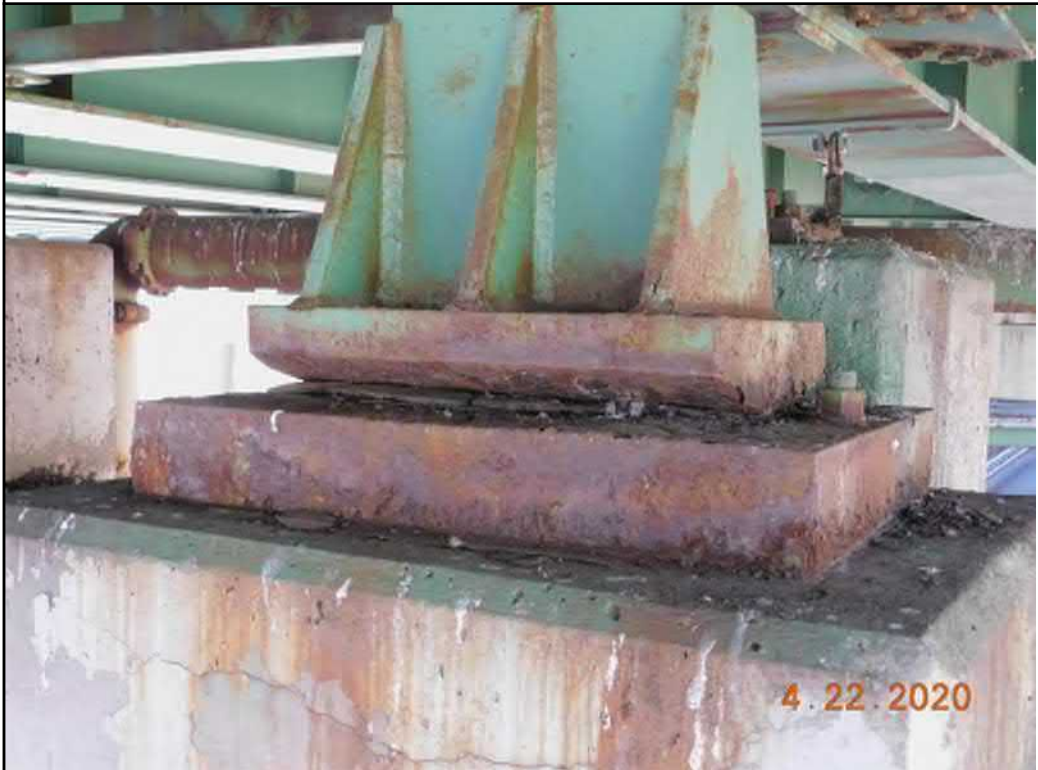
Photo Number: 34

Location: Pier 6, Bearing G2, Span 7 side; Looking Back. Pack rust between rocker and masonry plate and deteriorated paint. (Typical)

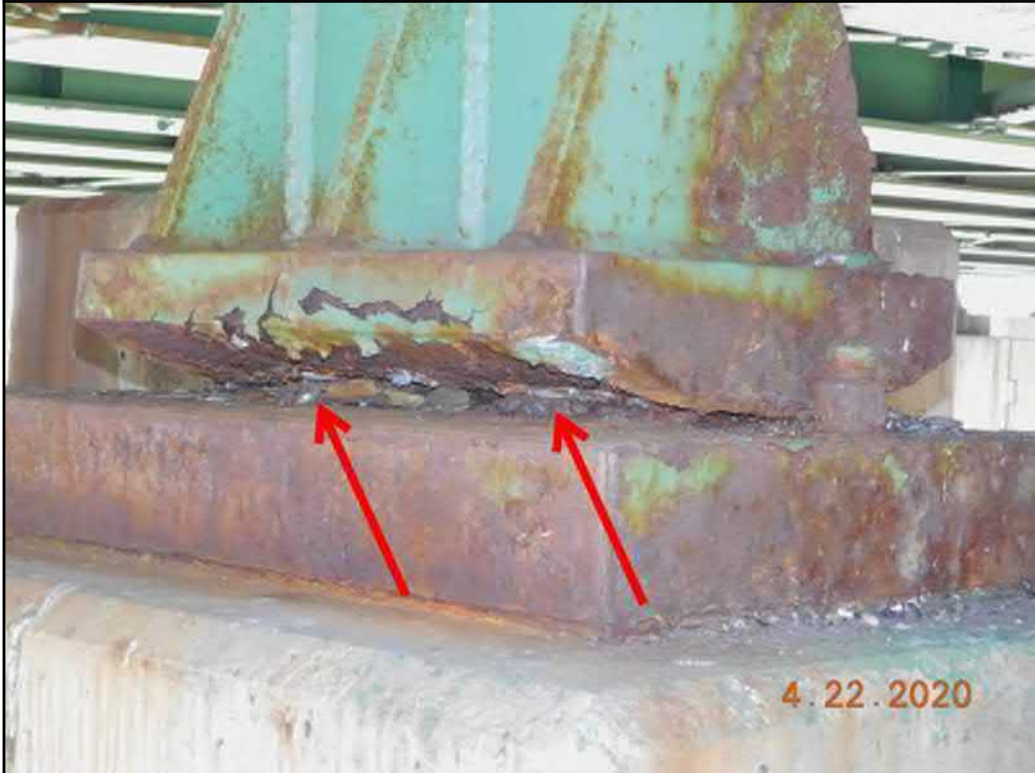
Photo Number: 35 Photo Filename: 20\_SW\_5621.JPG

**Attachment Description:**  
Location: Pier 6, Bearing  
G5, Span 7 side; Looking  
Back and Right. Pack rust  
with exposed pintels.

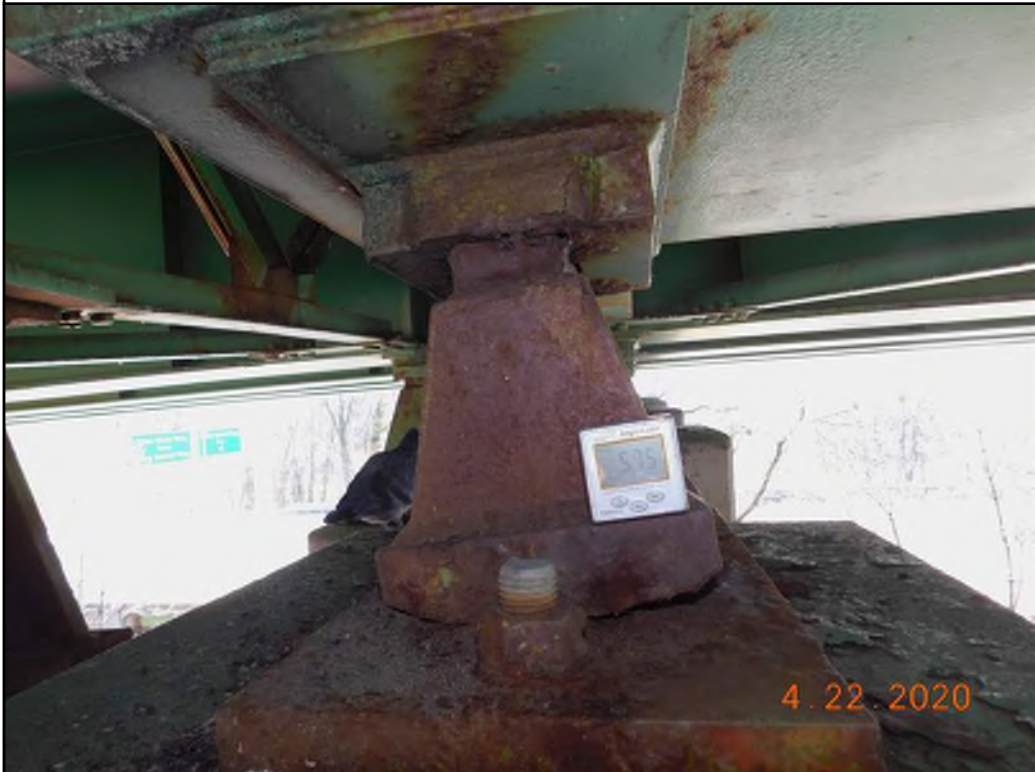
Photo Number: 36 Photo Filename: 20\_SW\_5637.JPG

**Attachment Description:**  
Location: Pier 6, Bearing  
G14, Span 6 side; Looking  
Left. Bearing over-  
expanded.

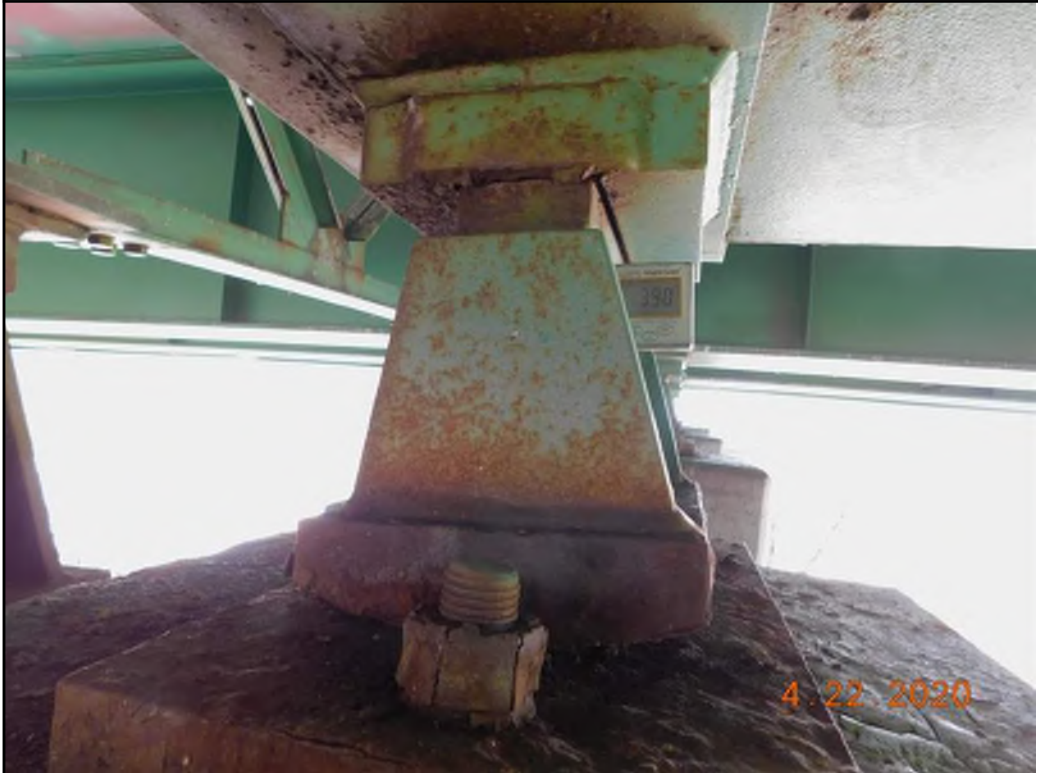
Photo Number: 37 Photo Filename: 20\_SW\_5638.JPG

**Attachment Description:**  
Location: Pier 6, Bearing  
G15, Span 6 side; Looking  
Right. Bearing over-  
expanded.

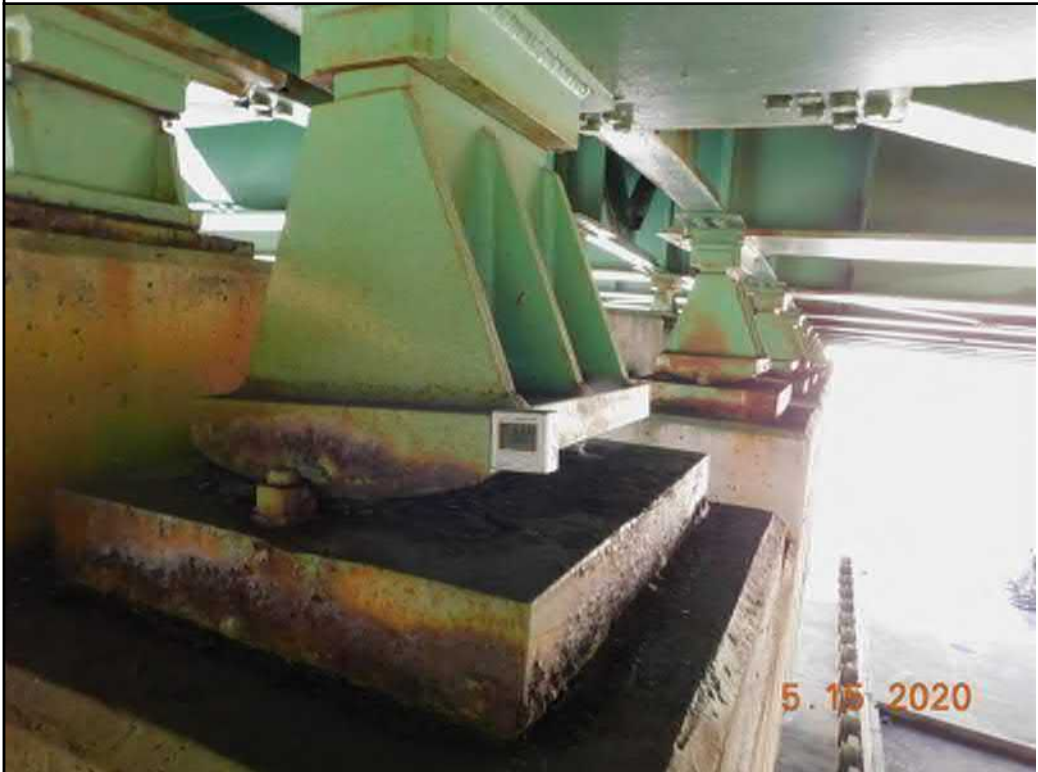
Photo Number: 38 Photo Filename: 20\_SW\_6122.JPG

**Attachment Description:**  
Location: Pier 9, Bearing  
G14, Span 10 side; Looking  
Left. Bearing over-  
expanded.

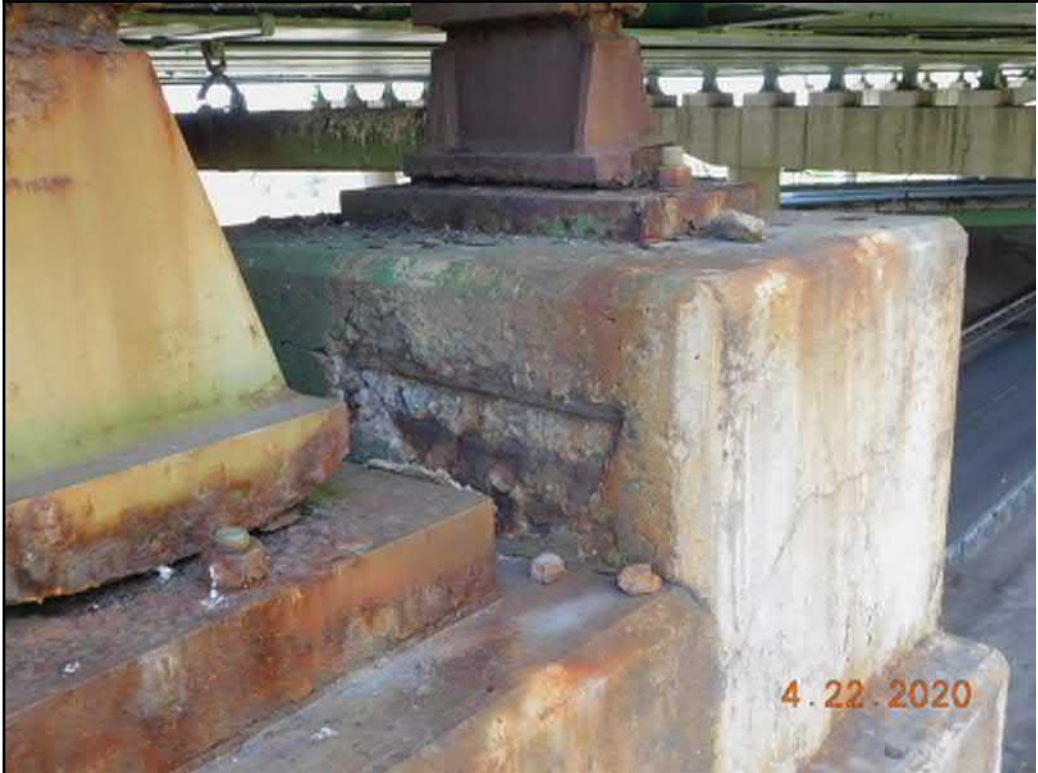
Photo Number: 39 Photo Filename: 20\_SW\_5617.JPG

**Attachment Description:**  
Location: Pier 6, Pedestal  
#1, Span 6 side; Looking  
Back and Right. Spall with  
exposed rebar.

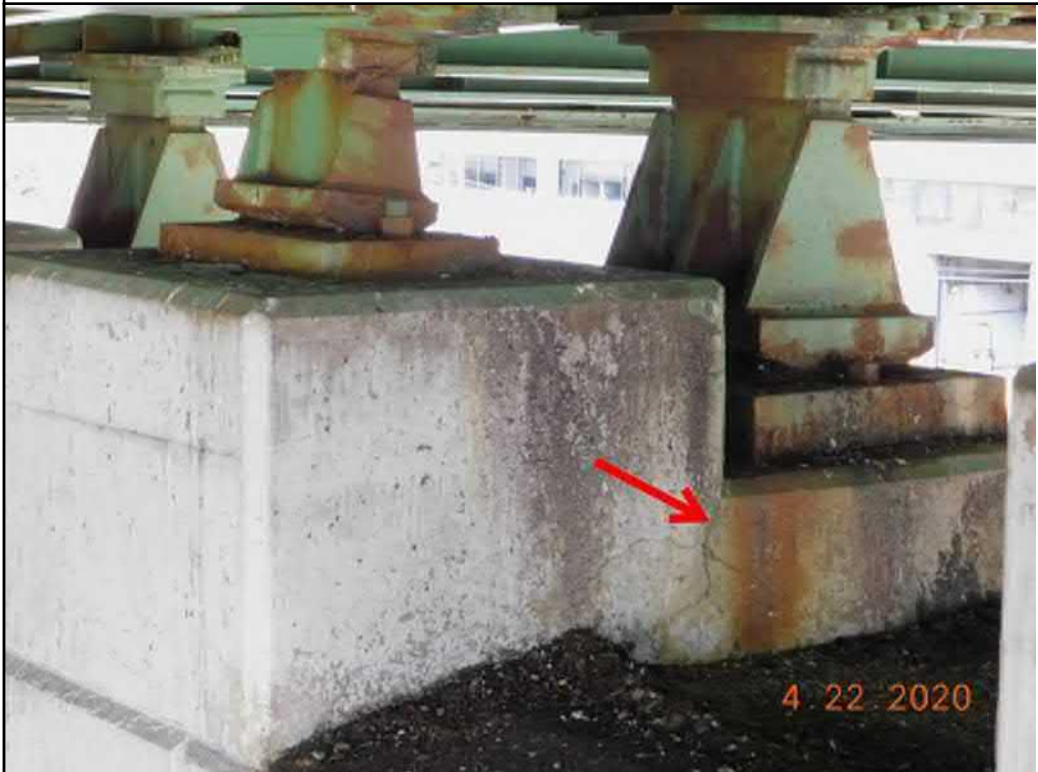
Photo Number: 40 Photo Filename: 20\_SW\_5641.JPG

**Attachment Description:**  
Location: Pier 6, Pedestal  
#15 (both spans); Looking  
Ahead and Left. Cracks at  
right face between Girder  
G15 pedestals.
